CASE STUDY 1

HAMPTON AVE.

LESSON LEARNED! CLEAN FILTERS COUNT

INSTALLATION OF AUTOMATED RAIN BARREL (ARB) SYSTEM

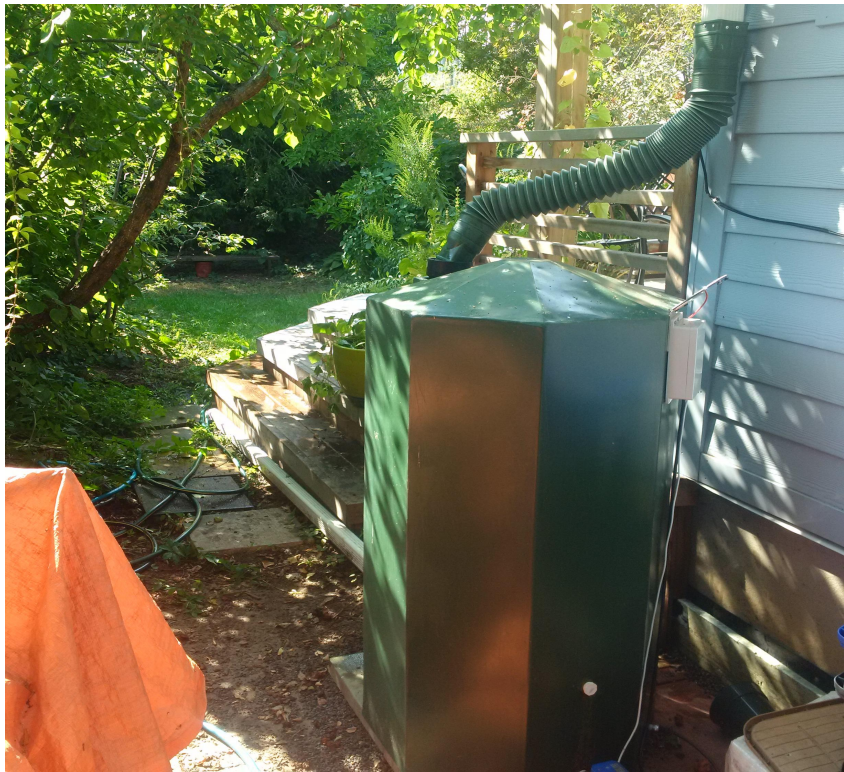
Figure 1.1: Installation of ARB system on Hampton Ave.

Rain Barrel: The 500 L rain barrel (RB) was installed by the south eastern (back) corner of the house (fig. 1.1). The installation was somewhat challenging due to its location between the two houses; there is less than XX m (10 ft.) clearance between the wall of this house and the property line of the neighbouring one. The roof collection surface was estimated to be 4.5 x 6 m (15 x 20 ft.), or 28 m² (300 sq. ft.). A standard 7.5 x 5 cm (3 x 2 in.) downspout fitted to our customized storm funnel connects to the diverter box. There is excellent drainage around the gravel base but the tree coverage of the roof area was at 100 percent.

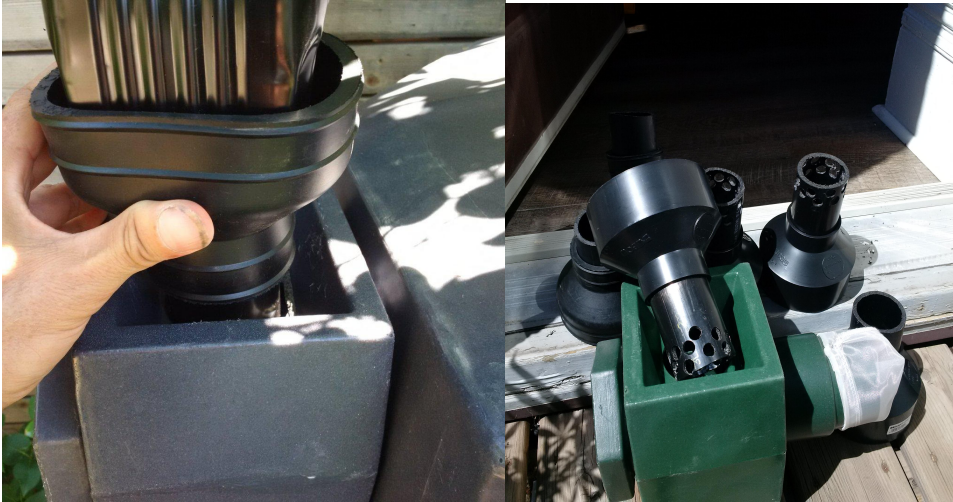
We discovered that each storm brought surges of rain that flowed in a highly agitated and turbulent way off the roof surface and into the downspouts, which overwhelmed the diverter box and the overflow diverter box to the secondary drainage area. This led to significant reduction in the verifiable volume of stormwater collected, stored, and therefore available for homeowner use. To rectify this issue we custom designed what we call a “storm funnel” (fig. 1.2) The storm funnel connects the downspout to the diverter box. It focuses the rainwater directly into the diverter valve, largely eliminating the overflow issue and more than doubling capture rates in many instances.

Figure 1.2: LEFT: Storm funnel (black) in diverter box (grey). RIGHT: Uninstalled storm funnels (black) and diverter box (green) with filter (white).

Solutions: Storm-funnel installation, predictable filter-maintenance notifications, more reliable sensors and data set clean up would resolve these challenges.

We rectified this issue on this Hampton Ave. rain barrel, and then on all of the rain barrel installations in the pilot project, by making and installing a “storm funnel” (see fig. 1.2). Subsequent to these modifications and regular filter cleaning, we recorded collection volumes five to ten times the volumes collected in similar storms in July. Similar results were seen on many of the other rain barrel installations once storm funnels were added. This storm-surge issue was unexpected and had not been identified as an issue in any of the RB installation protocols.

Recommendation: That the storm-surge funnel and/or diverter box design be added to the installation instructions and equipment for the rain barrel (a product of RainGrid Inc.).

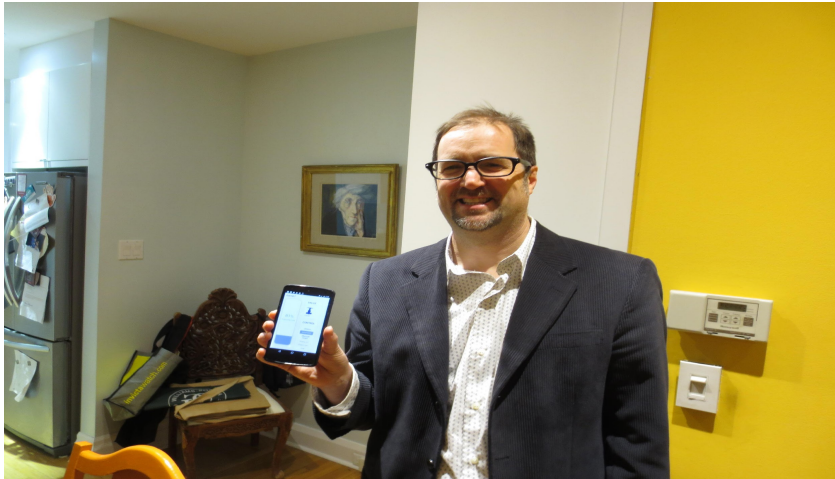
Figure 1.3. Andrew S. shows the phone app that monitors and controls his new ARB system.

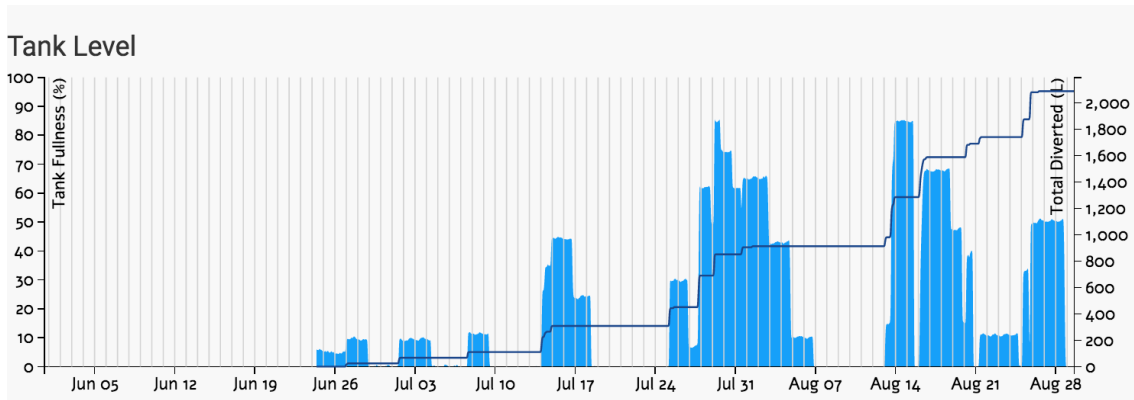
Online Dashboard: During the first five storm events in June and July the system administrator and householder identified very low capture rates, less than 50 L / storm (see fig. 1.4). We investigated more closely, cleaned the filters weekly (identifying extensive build up from roof dirt and silt as well as leaves and immature fruit from overhanging tree). However, even with clean filters we observed that storm-surge overflow was occurring. This happened when the initial volume and intensity of rainwater coming off the roof overwhelmed the chamber in the diverter valve (see fig. 1.2) and resulted in water bypassing the rain barrel to the overflow drainage area.

Figure 1.4: Rainfall-collection, tank-level, and water-use/drainage metrics for Hampton Ave. from June 23 to August 28.

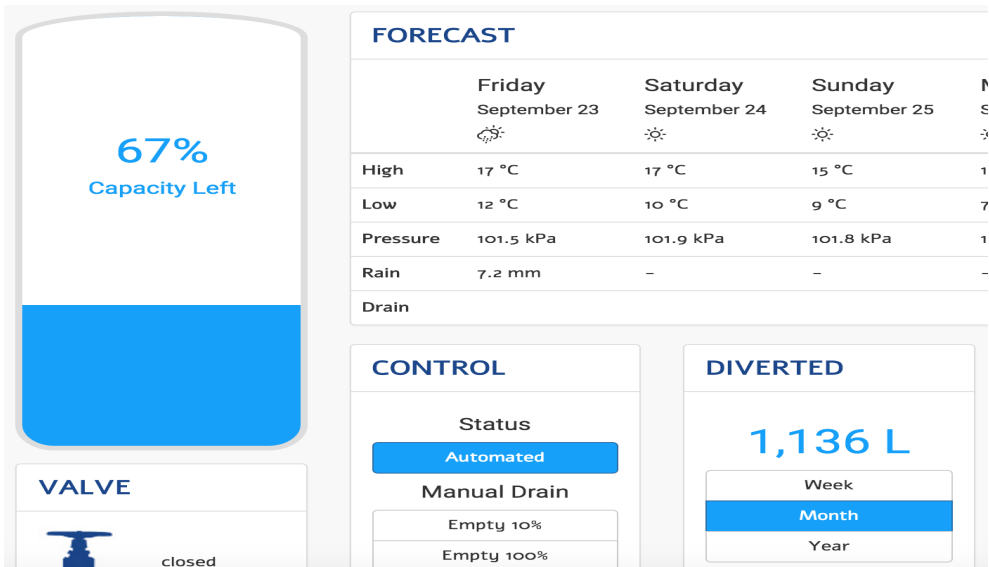
Figure 1.10: Dashboard showing 1,136 L rainwater diverted in one-month period at Hampton Ave.

This dashboard (see fig. 1.10) shows monthly collection metrics of 1,136 L. This was during a period of relatively low rainfall (about five rain events) but during a time when the filters were well maintained and the storm funnel installed.
