CASE STUDY 4

CAVELL AVE.

GARDENING WITH SOAKER-HOSE IRRIGATION USING AN ARB SYSTEM

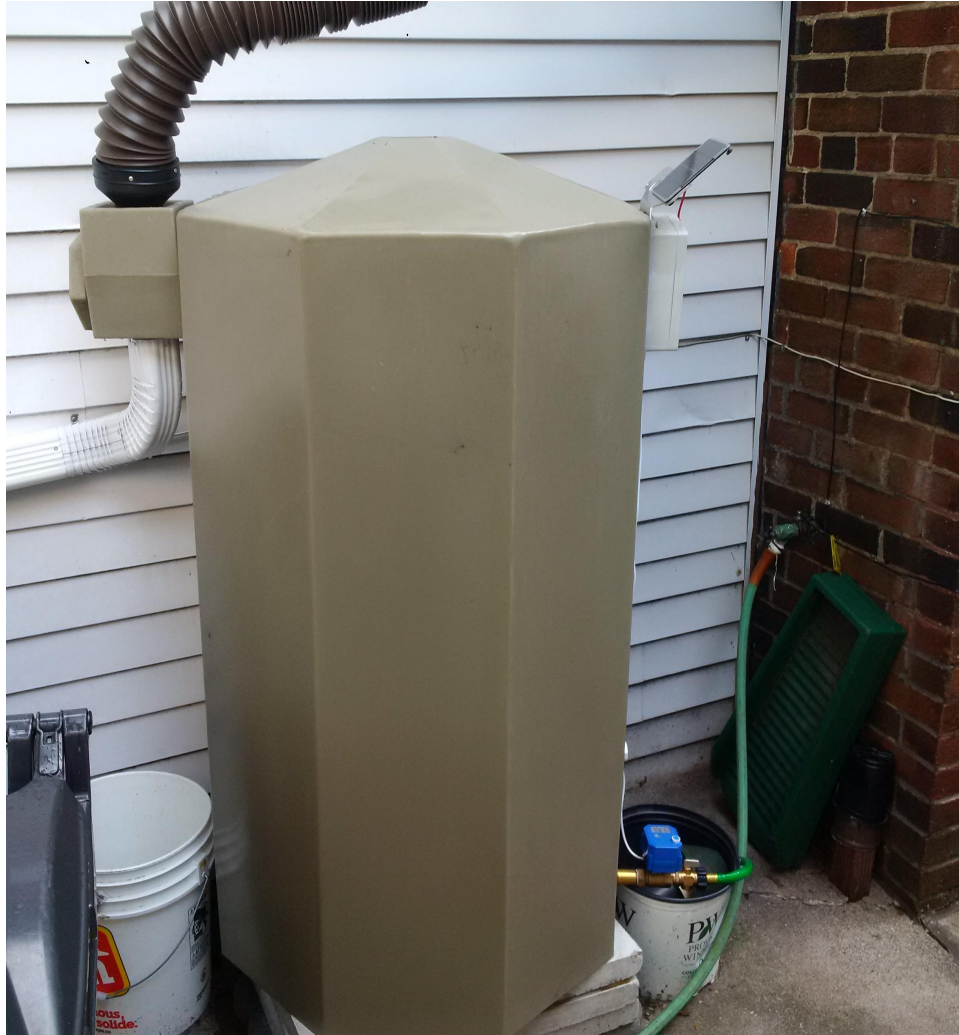
Figure 4.1: Installed Cavell Ave. ARB system with solar panel (right) and storm funnel attachment (left).

This rain barrel installation was raised approximately 24 cm (8 in.) with paver stones at its base (see fig. 4.1) in order to ensure gravity-fed drainage to the backyard raised-bed garden.

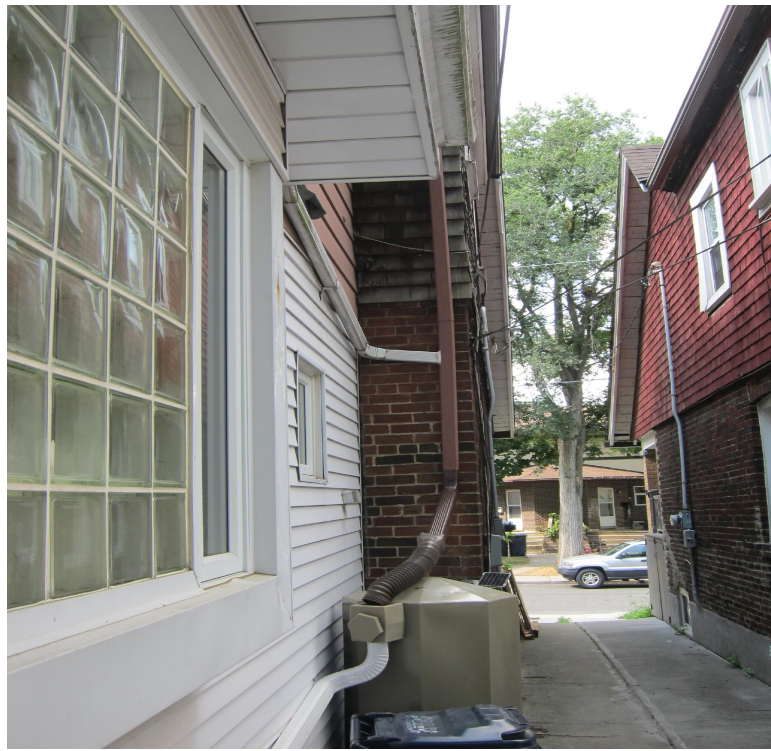
Figure 4.3: North-facing view of Cavell Ave. fully installed ARB system, with downspout disconnected from the storm sewer and overflow and bypass running along house to French drain (not pictured).

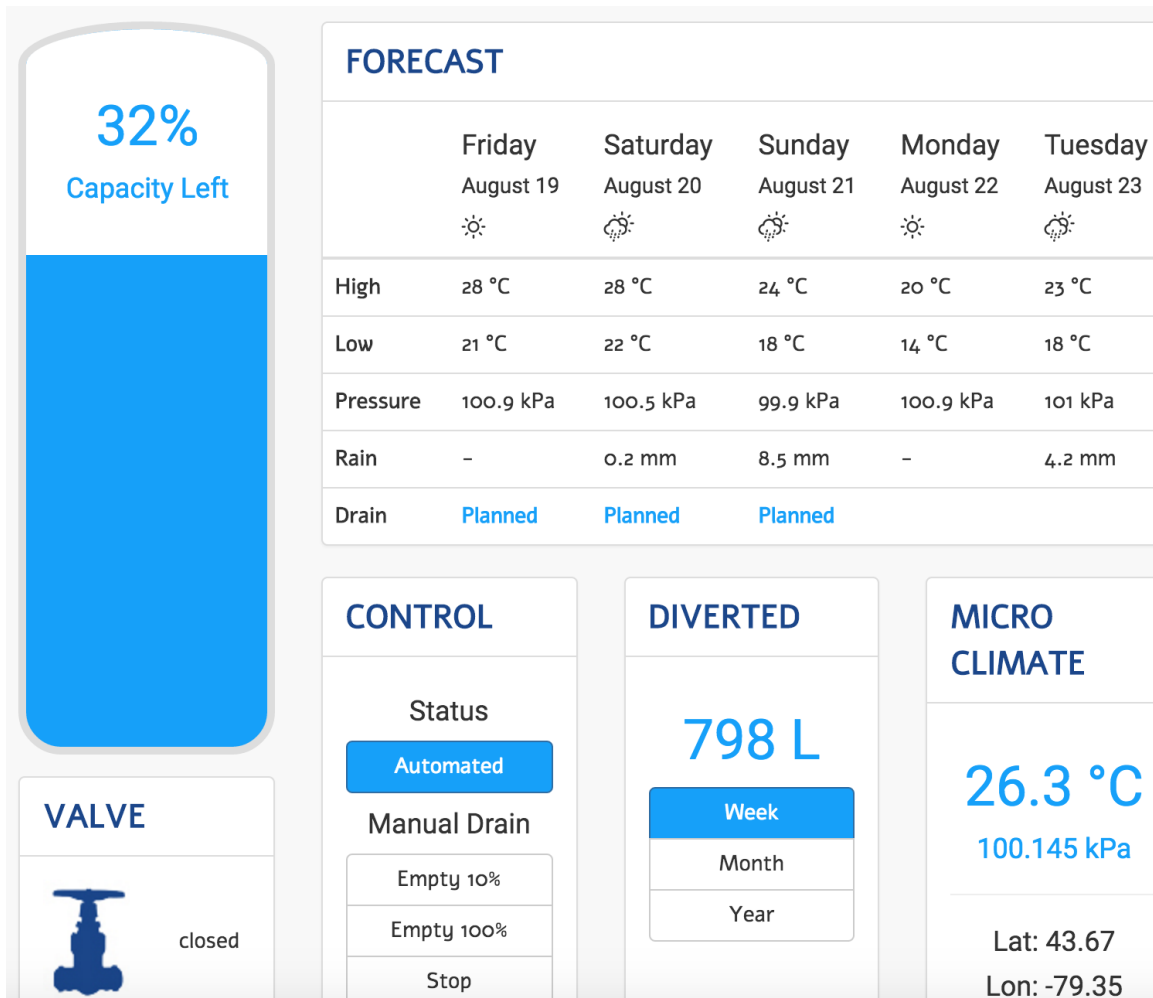
Figure 4.8: Rainwater diversion metrics for Cavell Ave., over one week.

The dashboard shown in fig. 4.8 shows that this ARB system installation collected, stored, and diverted 798 L in one week.
