CASE STUDY 5

WITHROW AVE.

ARB SYSTEMS AND RAIN GARDENS: INTEGRATING URBAN GREEN INFRASTRUCTURE

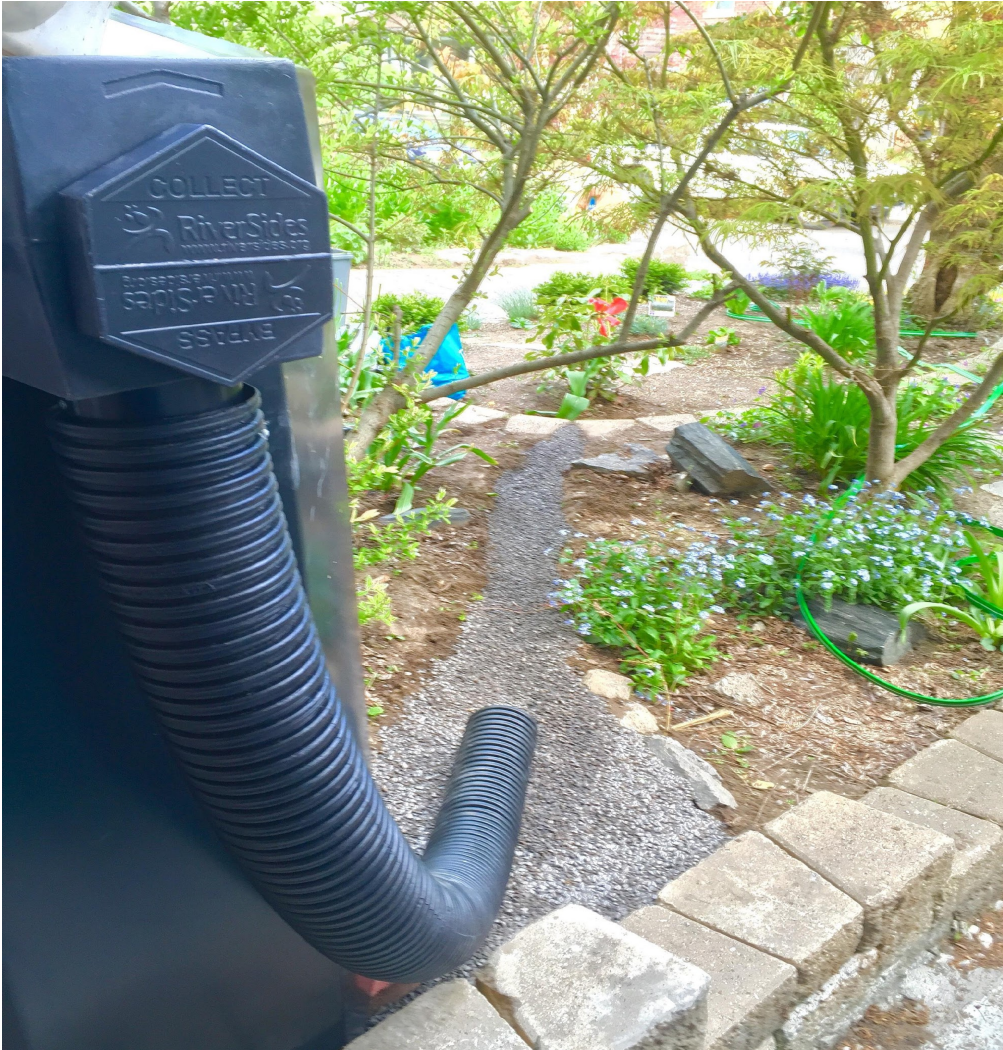
Figure 5.1: Rain barrel diverter and bypass flowing to rain garden on Withrow Ave.

Even in overflow or bypass conditions, this household's rain barrel disperses rainwater and drains it to the rain garden (see fig. 5.1). Consequently, stormwater is collected or absorbed before it makes it to the street or sewer.

Overflow, Bypass, and Drainage: This installation featured an excellent opportunity to combine the benefits of the ARB system with a rain garden, making the best use of clean technology and green infrastructure to prevent residential flooding and water pollution and to reduce municipal water used on a garden. The homeowners used an older type of soaker hose that drained quickly and effectively when fed by automated or manual drainage. In this way, rainwater from the barrel was dispersed, from the convenience of the online dashboard, throughout the garden via a 9 m (30-ft.) soaker hose, and the gradient away from the house allowed this system to take advantage of gravity to drain the RB effectively. Overflow and bypass water is directed to a gravel rain garden that flows into the landscaped front yard. The

soils are sandy loam and drain well despite heavy rainfalls, and the relatively steep gradient means there is no longer surface stormwater run-off to the street.

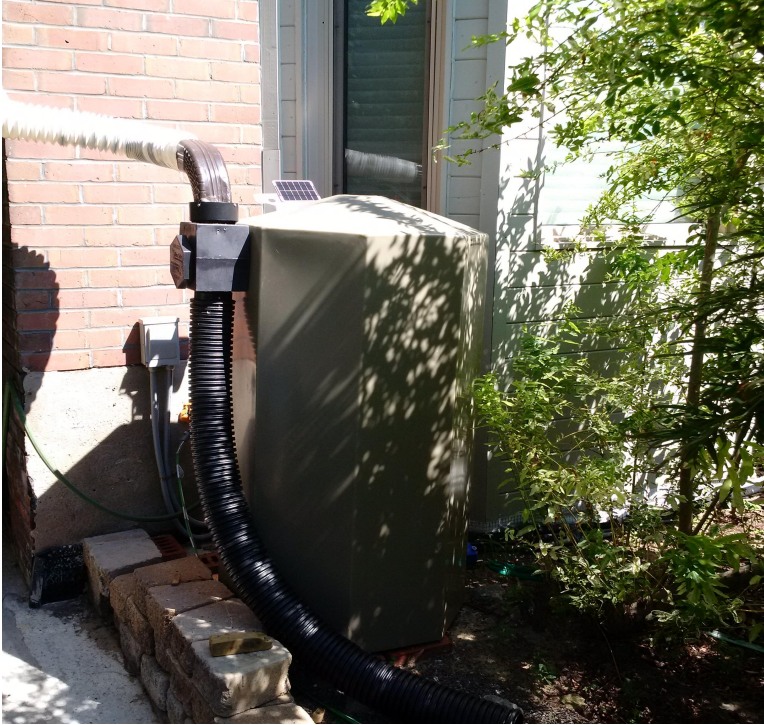
Figure 5.2: Installed ARB system at Withrow Ave., with storm funnel attachment (to the left) and solar panel (at the back).

Rain Barrel: The ARB was installed in the south western (front) corner of the house (see fig. 5.2). The roof collection surface was estimated at about 4.5 x 9 m (15 x 30 ft.), or 41 m² (450 sq. ft.) A standard 7.5 x 5 cm (3 x 2 in.) downspout fitted to the customized storm funnel connects to the diverter box. There is excellent drainage around the gravel base, a gradient away from the house foundation, and no significant tree coverage of the roof collection area. The front yard is elevated from street level by about two meters.

Automated Controller, Plug-in Modem, and Solar Panel: The automated controller was installed and tested and went into operation on August 13. The 12 x 12 cm (4 x 4 in.) solar panel was installed directly on the barrel and, although partially shaded by trees, had south-facing exposure, so no power issues were experienced during the 2016 pilot project.

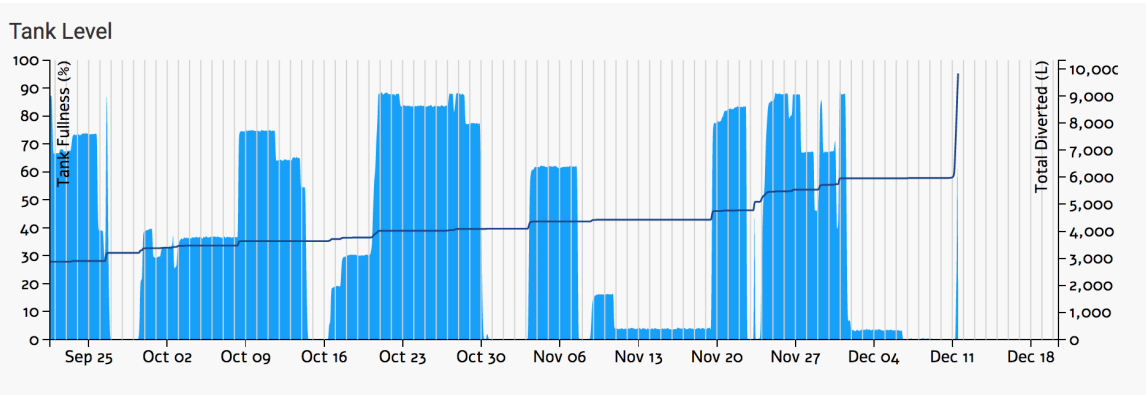
Figure 5.4: Rainfall-collection, tank-level, and water-use/drainage metrics for Withrow Ave., from September 21 to December 1.

As clearly demonstrated by the tank level (see fig. 5.4), the Withrow Ave. installation, once operational, was regularly filling to 80 to 90 % capacity. By December 1 it had a verified collection of about 6,000 L over a 3.5-month period. The December 11 spike in collection reflects a sensor failure due to sub-zero conditions.

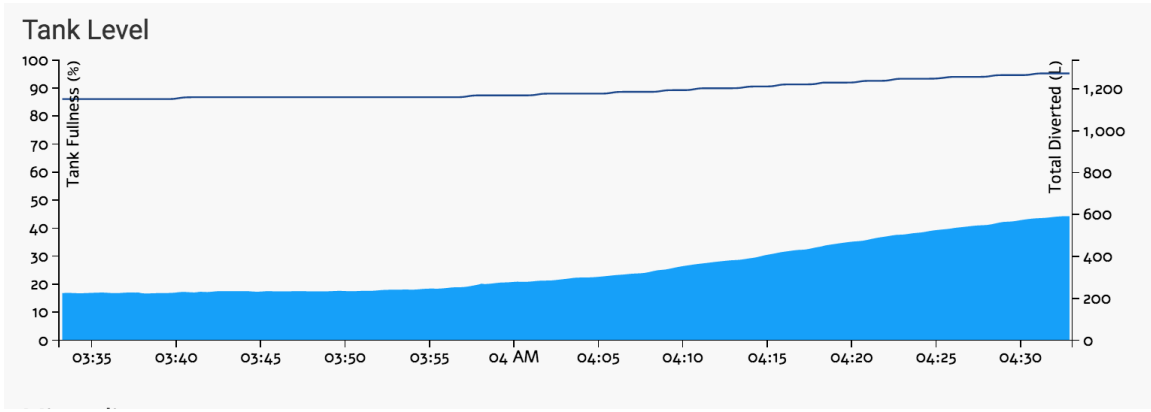
Figure 5.6: Tank level showing rain barrel filling over one hour at Withrow Avenue.

The graph in fig. 5.6 shows the rain barrel filling in a light rain over a one-hour period demonstrating good steady collection.
